B.1 Incense Tree Aquilaria sinensis

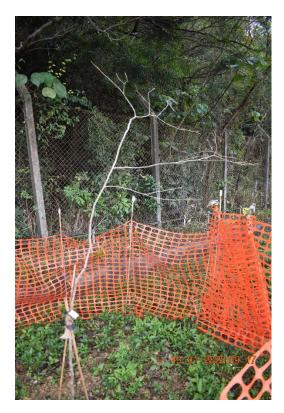
Photo B.1.1.: General view of the transplanted individual AS-03.

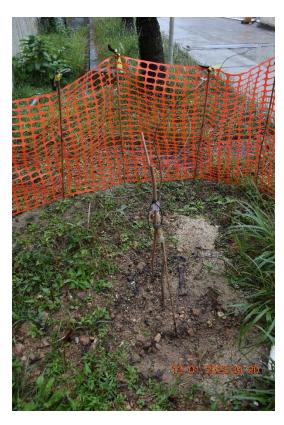
Photo B.1.3.: General view of the transplanted individual AS-02.

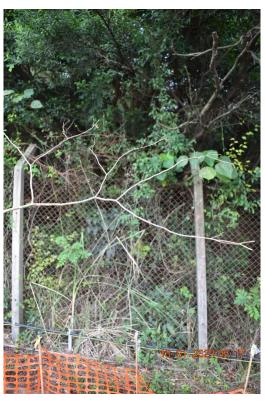
Photo B.1.2.: Branch condition of the transplanted individual AS-03.

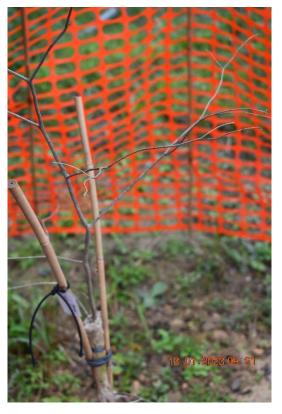
Photo B.1.4.: Branch condition of the transplanted individual AS-02.

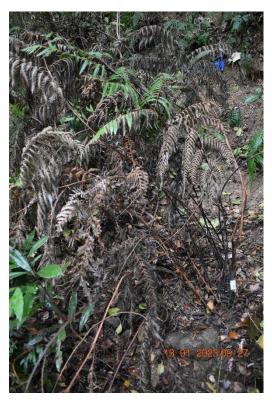
Photo B.2.1.: General view of the transplanted individual CB-01.

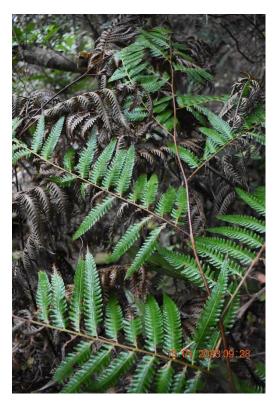
Photo B.2.3.: Leaf condition of the transplanted individual CB-01.

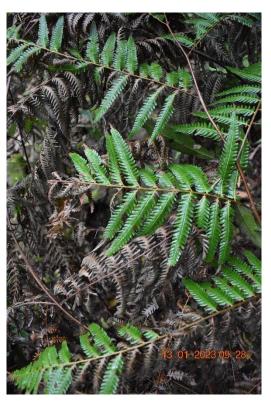
Photo B.2.2.: Leaf condition of the transplanted individual CB-01.

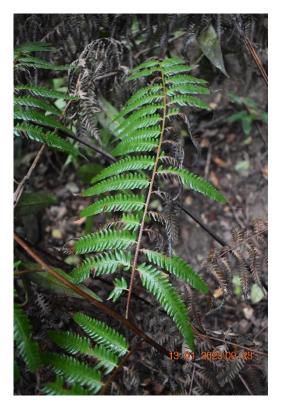
Photo B.2.4.: Leaf condition of the transplanted individual CB-01.

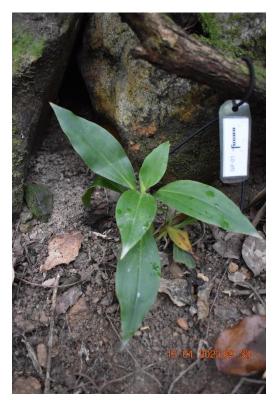
Photo B.3.1: Individual GP-01. Partially wilted leaf.

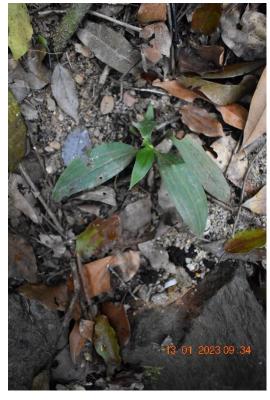
Photo B.3.4: Individual GP-03. Perforated leaves.

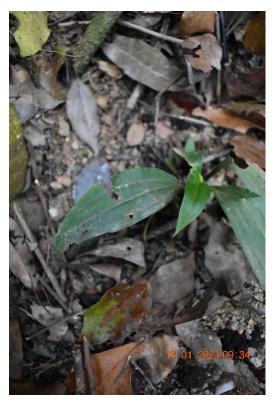
Photo B.3.5: Individual GP-03. Perforated leaves.

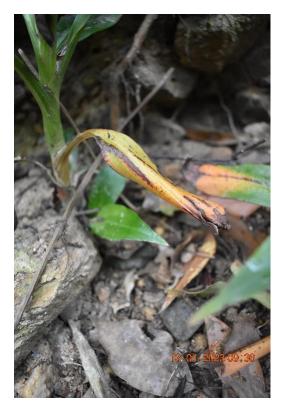
Photo B.3.7: Individual GP-04. Wilted leaf.

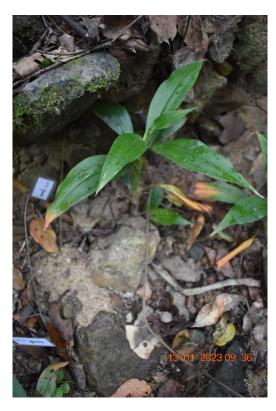
Photo B.3.6: Individual GP-04. Wilted leaf.

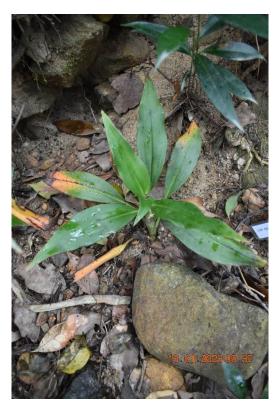
Photo B.3.8: Individual GP-05. Partially wilted leaf.

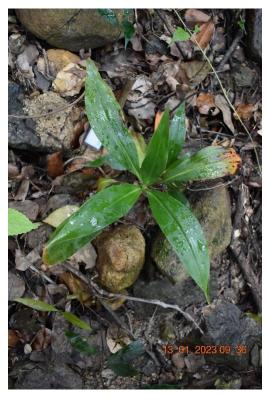
Photo B.3.9: Individual GP-06. Partially wilted leaf.

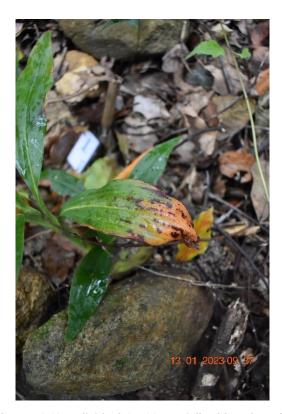
Photo B.3.10: Individual GP-06. Partially chlorotic and wilted leaf.

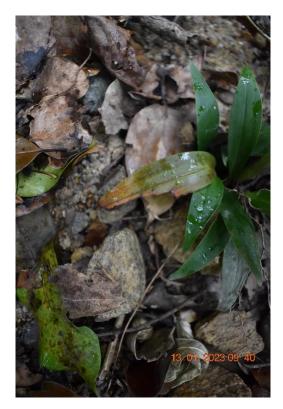
Photo B.3.12: Individual GP-07. Single chlorotic leaf.

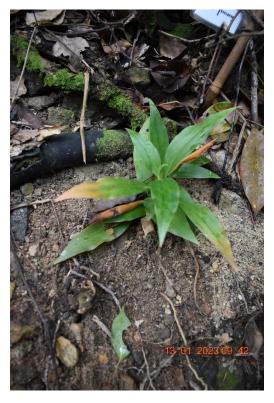
Photo B.3.13: Individual GP-08. Chlorotic leaves.

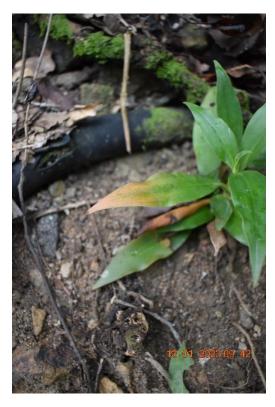
Photo B.3.14: Individual GP-08. Minor chlorotic leaves.

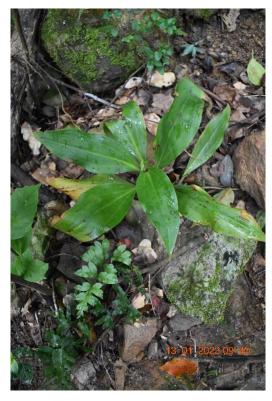
Photo B.3.16: Individual GP-10. Holes in leaves.

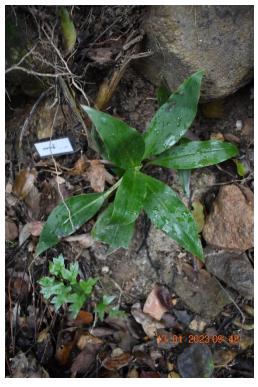
Photo B.3.17: Individual GP-11. Partially wilted leaves.

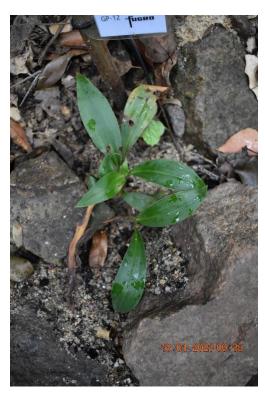
Photo B.3.18: Individual GP-12. Perforated leaves.

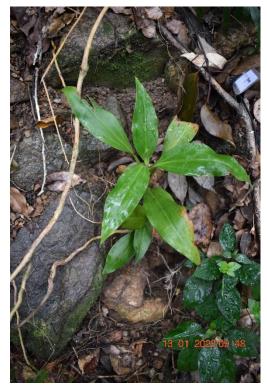
Photo B.3.20: Individual GP-14. Chlorotic leaves.

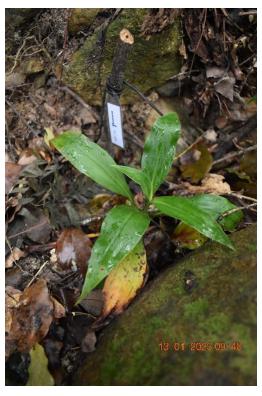
Photo B.3.21: Individual GP-15. Partially chlorotic leaves.

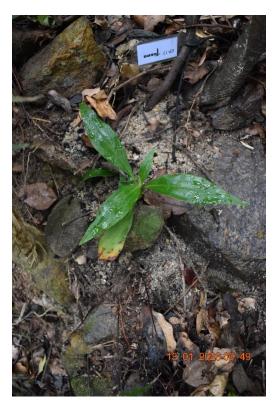
Photo B.3.23: Individual GP-17. Partially wilted leaf.

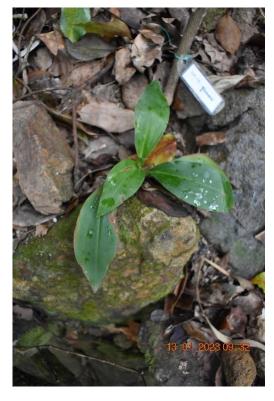
Photo B.3.24: Individual GP-18. Partially wilted leaves.

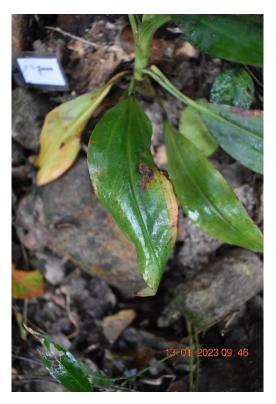
Photo B.3.26: Individual GP-19. Chlorotic and partially wilted leaves.
