B.1 Incense Tree Aquilaria sinensis

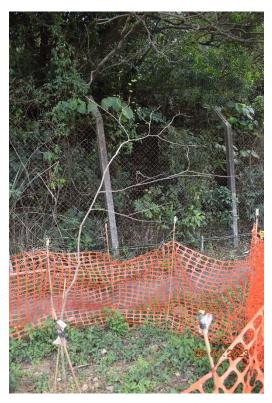
Photo B.1.1.: General view of the transplanted individual AS-03.

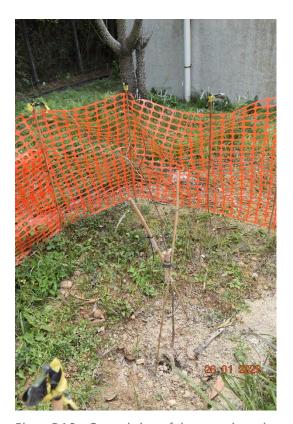
Photo B.1.3.: General view of the transplanted individual AS-02.

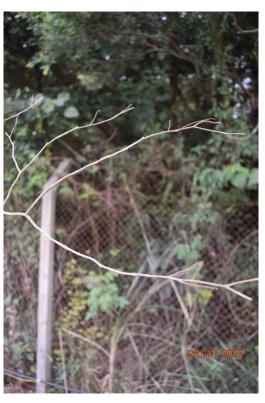
Photo B.1.2.: Branch condition of the transplanted individual AS-03.

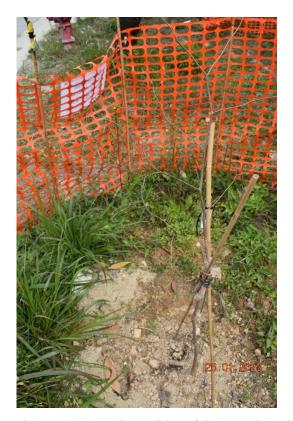
Photo B.1.4.: Branch condition of the transplanted individual AS-02.

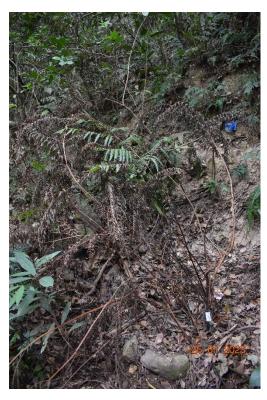
Photo B.2.1.: General view of the transplanted individual CB-01.

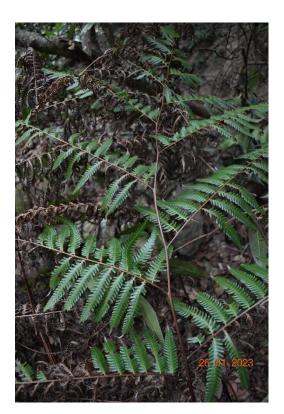
Photo B.2.3.: Leaf condition of the transplanted individual CB-01.

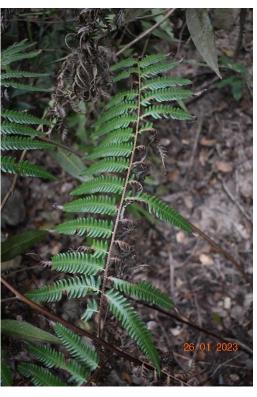
Photo B.2.2.: Leaf condition of the transplanted individual CB-01.

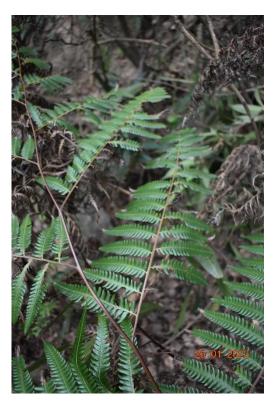
Photo B.2.4.: Leaf condition of the transplanted individual CB-01.

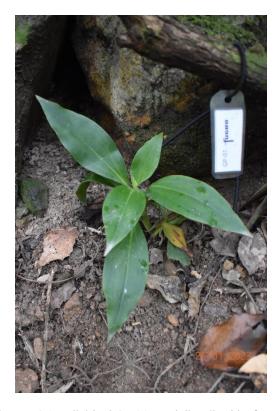
Photo B.3.1: Individual GP-01. Partially wilted leaf.

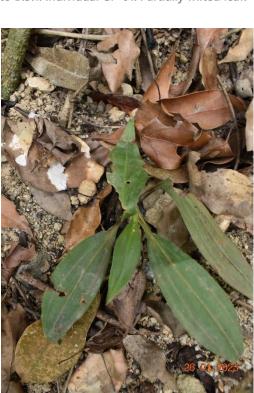
Photo B.3.3: Individual GP-03. Perforated leaves.

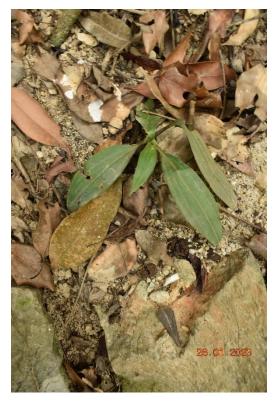
Photo B.3.4: Individual GP-03. Perforated leaves.

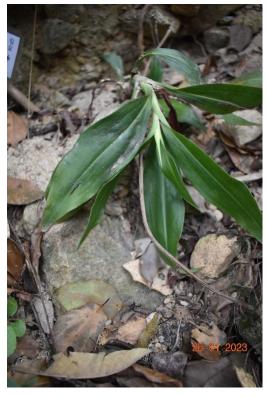
Photo B.3.5: Individual GP-04. Leaning.

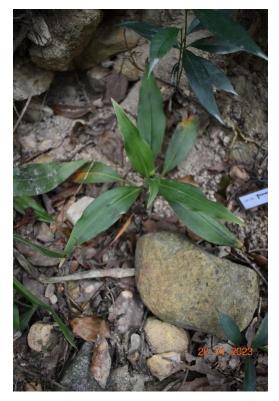
Photo B.3.7: Individual GP-05. Partially wilted leaf.

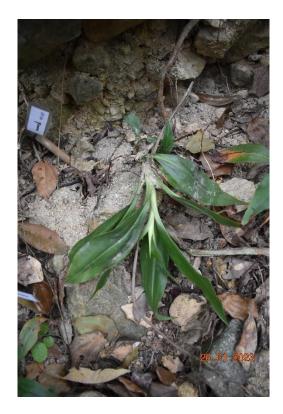
Photo B.3.6: Individual GP-04. Leaning.

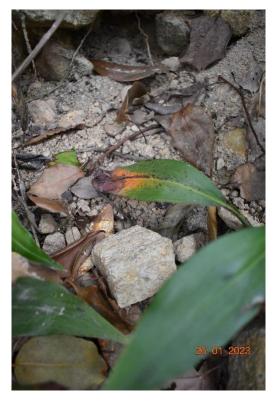
Photo B.3.8: Individual GP-05. Partially wilted leaf.

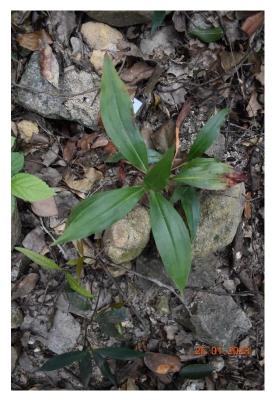
Photo B.3.9: Individual GP-06. Partially wilted leaf.

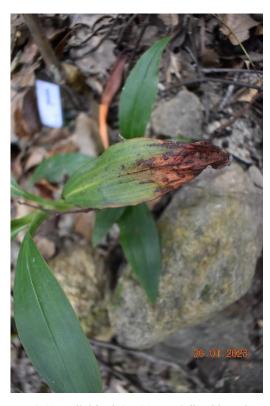
Photo B.3.10: Individual GP-06. Partially chlorotic and wilted leaf.

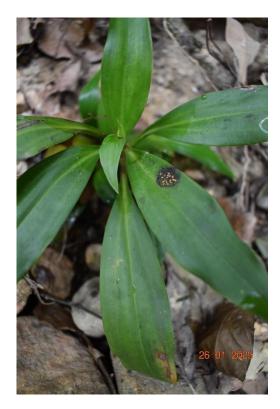
Photo B.3.12: Individual GP-07. Pest sign.

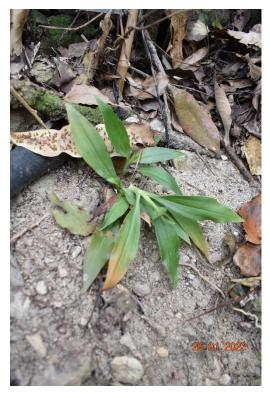
Photo B.3.13: Individual GP-08. Chlorotic leaves.

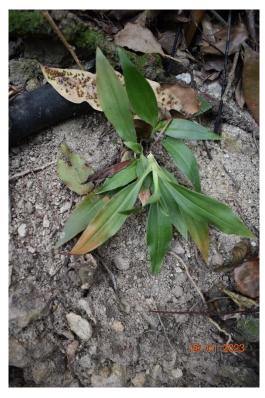
Photo B.3.14: Individual GP-08. Minor chlorotic leaves.

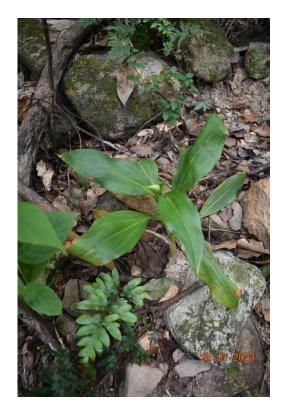
Photo B.3.16: Individual GP-10. Holes in leaves.

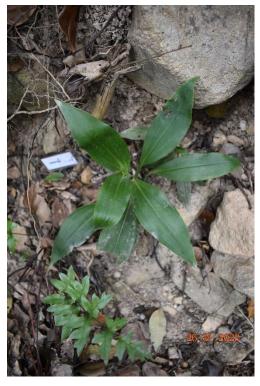
Photo B.3.17: Individual GP-11. Partially wilted leaves.

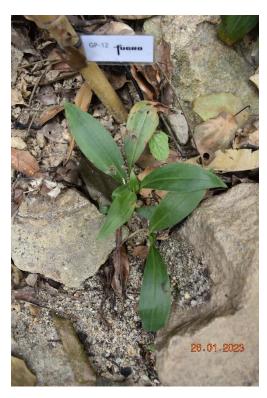
Photo B.3.18: Individual GP-12. Perforated leaves.

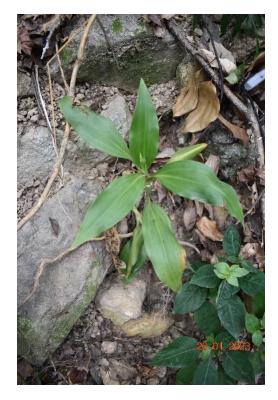
Photo B.3.20: Individual GP-14. Chlorotic leaves.

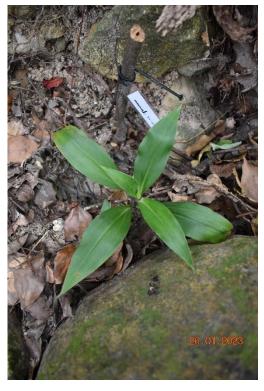
Photo B.3.21: Individual GP-15. Partially chlorotic leaves.

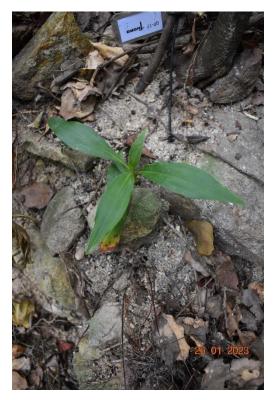
Photo B.3.23: Individual GP-17. Partially wilted leaf.

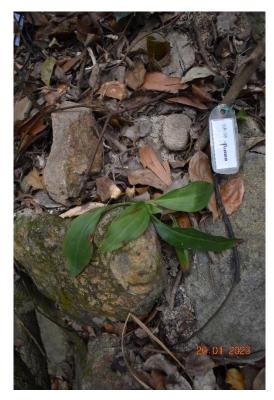
Photo B.3.24: Individual GP-18. Partially wilted leaves.

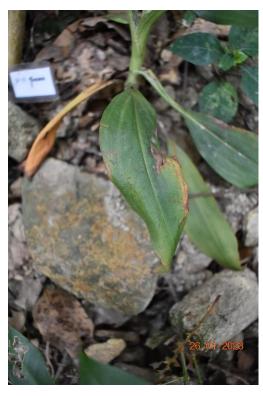
Photo B.3.26: Individual GP-19. Chlorotic and partially wilted leaves.
