11th Post-transplantation Monitoring and Audit Report (16th June 2023)

Northeast New Territories Landfill Extension (NENTX) | Contract No. EP/SP/77/15

0092/22/ED/0385 02 | 23 June 2023

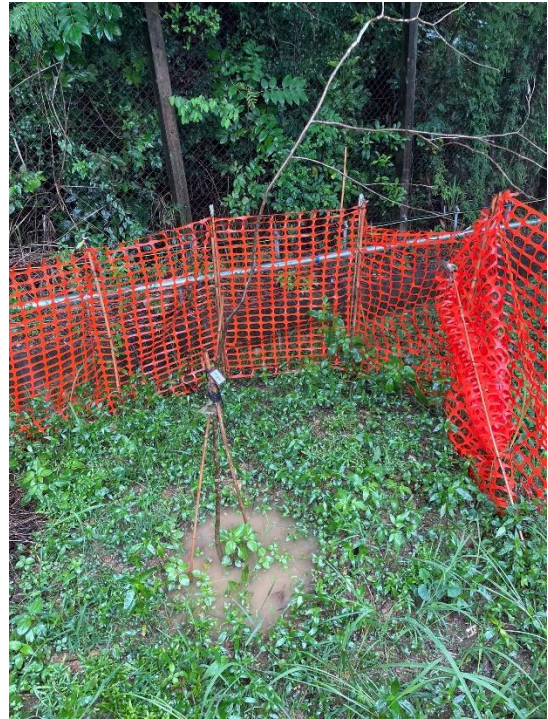
Photo B.1.2 : Stem condition of the transplanted individual AS-03.

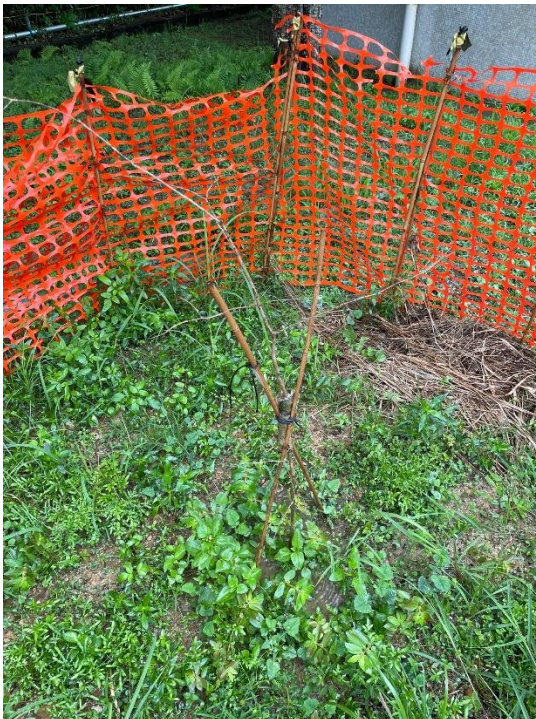
- 2.1.2 The Lamb of Tartary *Cibotium barometz* is in good condition. The new foliage is now very established and have been growing steadily.
- 2.1.3 The two saplings of the Incense Tree *Aquilaria sinensis* both demonstrated poor health conditions with die back and fallen leaves.

Photo B.1.3 : General view of the transplanted individual AS-02.

- The watering frequency for the two saplings of Incense Tree should be maintained at 2-3 times a week. Improve/place organic mulch around the two saplings of Incense Tree to retain soil moisture, protect damaged roots against extreme temperatures, and improve soil quality.
- The watering frequency of the cluster of Lamb of Tartary should be maintained at twice a week. Wilted leaves and stems should be pruned away.
- The watering frequency for all 19 clusters of Bottlebrush Orchid should remain the same. During watering activities, the surrounding dead branches and dry leaves should be removed to ensure no plants are damaged by them.
- Weed around the two Incense Tree saplings should be removed.
- The clusters of Bottlebrush Orchid *Goodyera procera* should be reinforced to prevent them from being washed away by heavy rain.

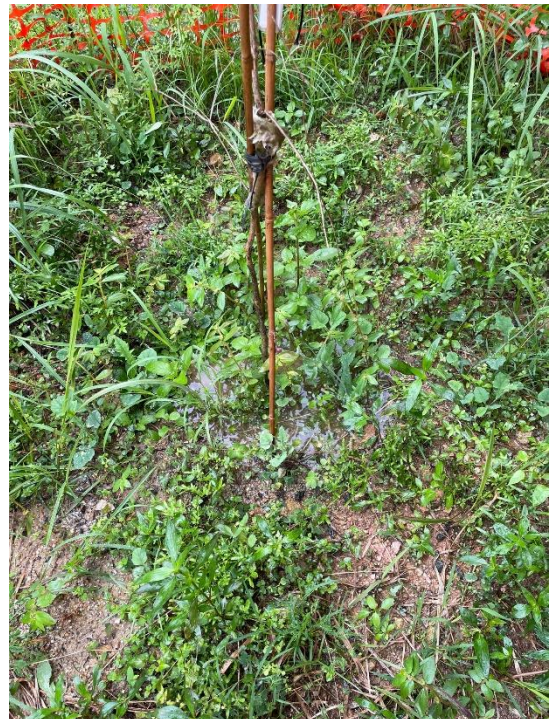
Photo B.1.4 : Stem condition of the transplanted individual AS-02.

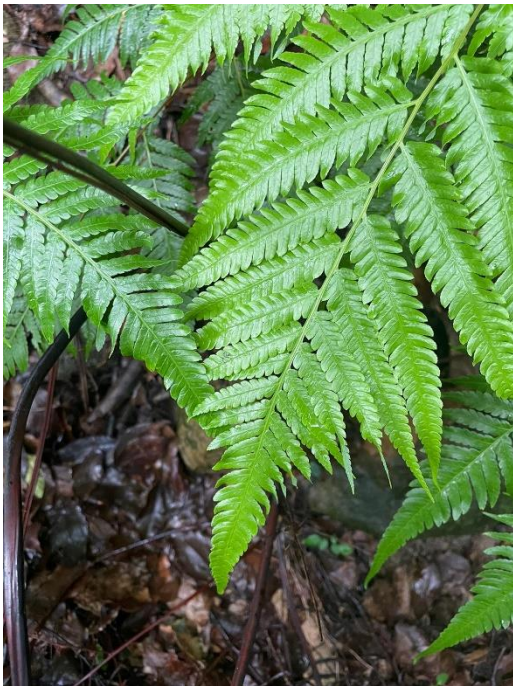
Photo B.2.3. : Leaf condition of the new foliage.

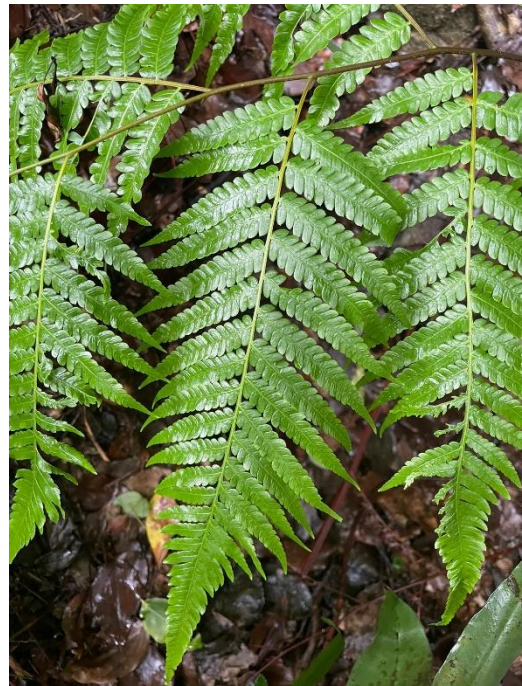
Photo B.2.4. : Leaf condition of the new foliage.

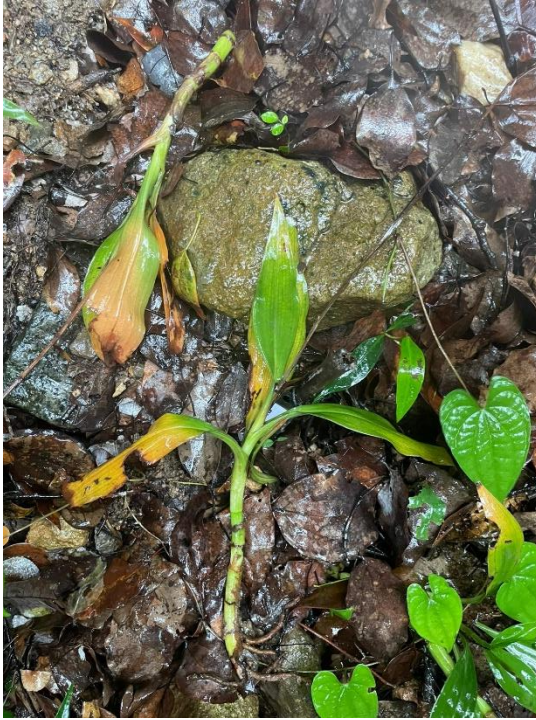
- 2.1.1 The majority of the transplanted individuals of the 19 clusters of Bottlebrush Orchid *Goodyera procera* were in fair to good condition with only minor health issues observed in some individuals, i.e., slightly chlorotic leaves and presences of holes in the leaves. However, three individuals (GP05, GP11, GP19) were dead and two (GP03, GP18) were missing in the current monitoring period. This could be due to disturbance from wild animals or the heavy rainfall.

- 2.1.5 The dead or missing individuals of Bottlebrush Orchid *Goodyera procera* could have been a result of wild animal disturbance or heavy rainfall.

Photo B.3.5: Individual GP-05. Dead.

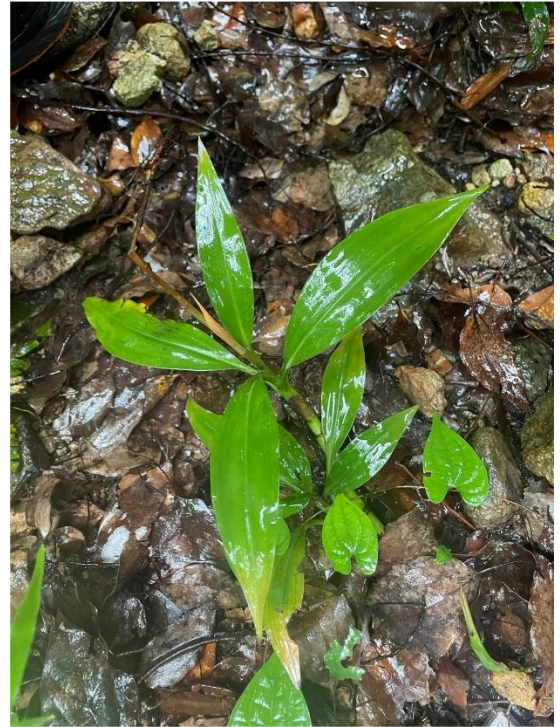
Photo B.3.6: Individual GP-06. Wilted flower.

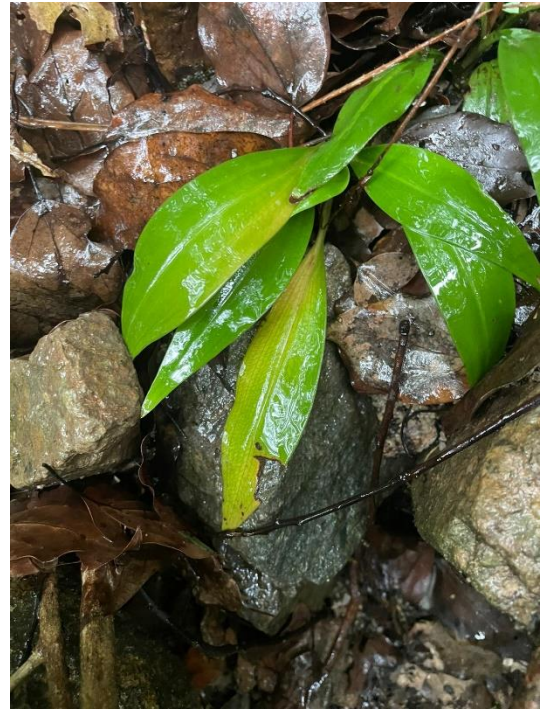
Photo B.3.14: Individual GP-13. Chlorotic leaves.
