14th Post-transplantation Monitoring and Audit Report (15th September 2023)

Northeast New Territories Landfill Extension (NENTX) | Contract No. EP/SP/77/15

0092/22/ED/0440 01 | 28 September 2023

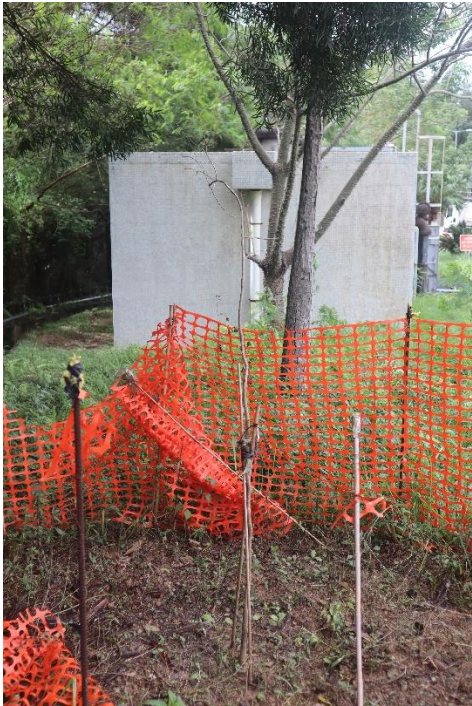
- 2.1.3 The Lamb of Tartary *Cibotium barometz* is in good condition. The new foliage is now very established and have been growing steadily.
- 2.1.4 One saplings of the Incense Tree *Aquilaria sinensis* (AS02) is dead. This could also be due to the recent rainstorm and tropical cyclone. The other (AS03) demonstrated poor health conditions with no foliage and fungi growing.

Photo B.1.1 : General view of the transplanted individual AS-03.

- The watering frequency for the two saplings of Incense Tree should be maintained at 2-3 times a week. Improve/place organic mulch around the two saplings of Incense Tree to retain soil moisture, protect damaged roots against extreme temperatures, and improve soil quality.
- The watering frequency of the cluster of Lamb of Tartary should be maintained at twice a week.
- The watering frequency for all clusters of Bottlebrush Orchid should remain the same. During watering activities, the surrounding dead branches and dry leaves should be removed to ensure no plants are damaged by them.
- Fencing around individual AS-03 should be reinforced.

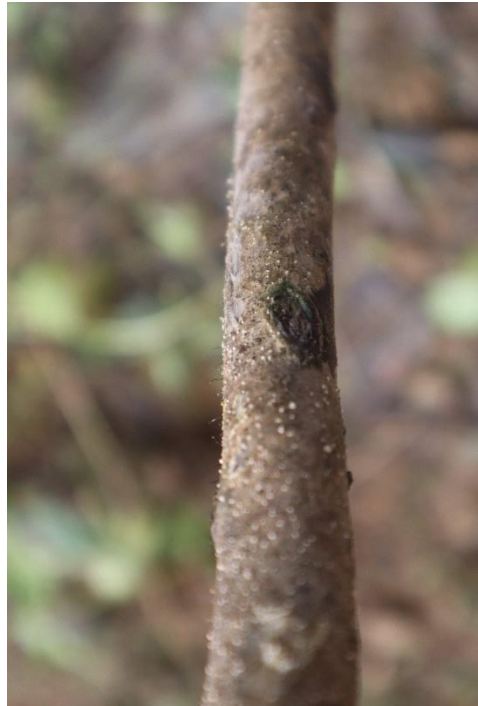
Photo B.1.2 : Stem condition of the transplanted individual AS-03.

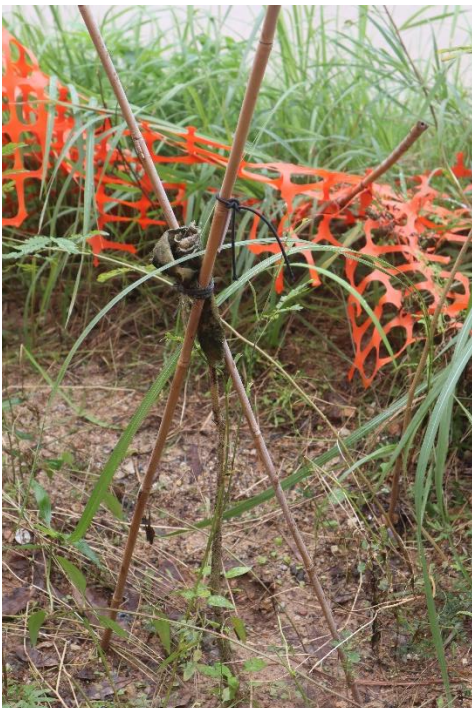
Photo B.1.3 : General view of the transplanted individual AS-02.

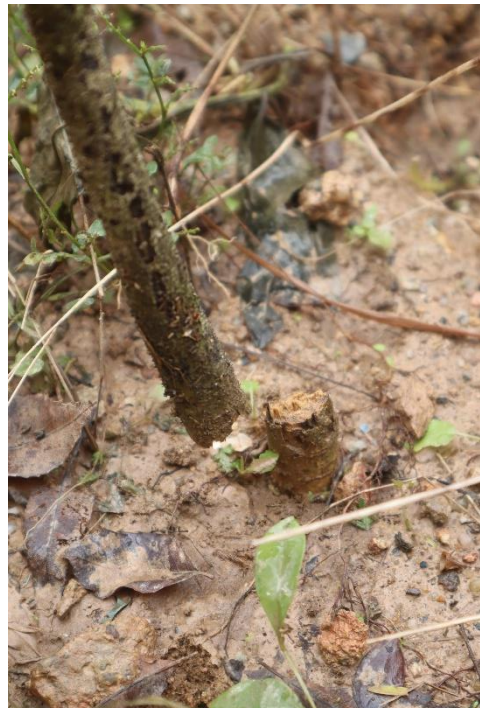
Photo B.1.4 : Broken stem of the transplanted individual AS-02.

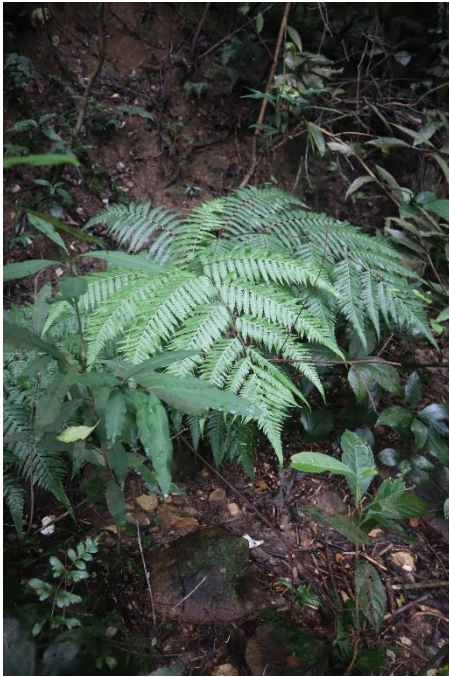
Photo B.2.1. : General view of the transplanted individual CB-01.

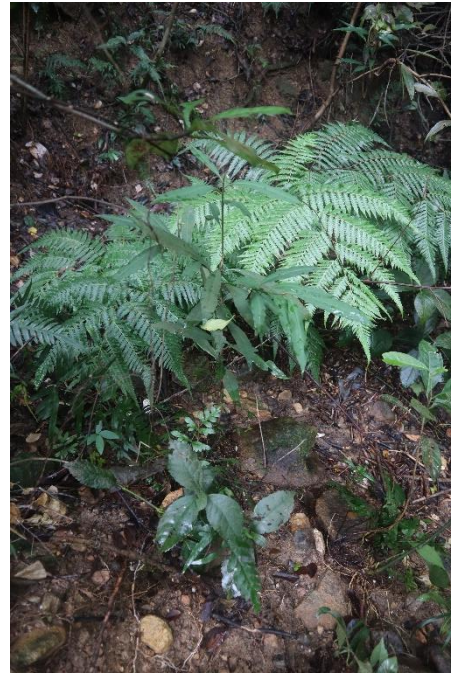
Photo B.2.2. : View of the transplanted individual CB-01.

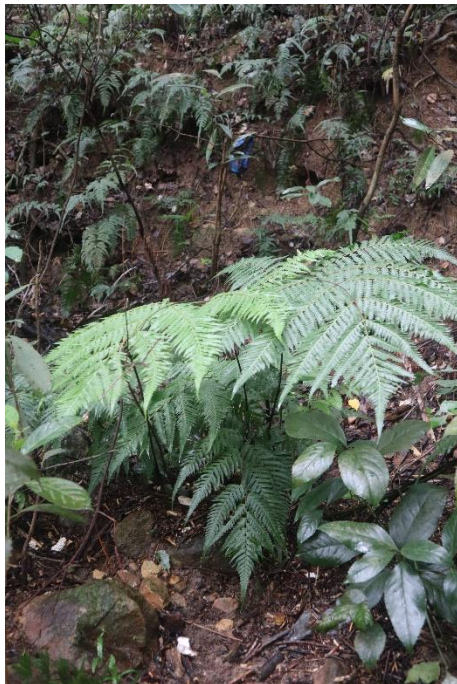
Photo B.2.3. : View of the transplanted individual CB-01.
