15th Post-transplantation Monitoring and Audit Report (13th October 2023)

Northeast New Territories Landfill Extension (NENTX) | Contract No. EP/SP/77/15

0092/22/ED/0448 02 | 16 October 2023

Re: Contract No. EP/SP/77/15
North-East New Territories Landfill Extension (NENTX)
15th Post-Transplantation Monitoring Report (13 October 2023)

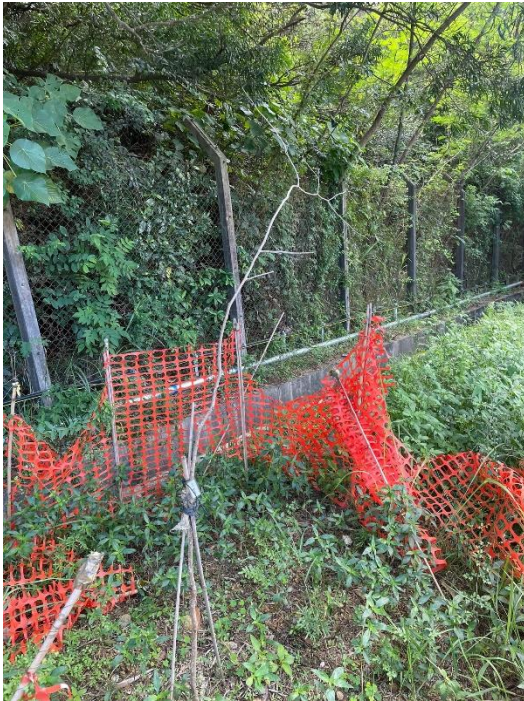
- 2.1.3 The Lamb of Tartary *Cibotium barometz* is in good condition. The new foliage is now very established and have been growing steadily.
- 2.1.4 One saplings of the Incense Tree *Aquilaria sinensis* (AS02) is dead. This could also be due to the recent rainstorm and tropical cyclone. The other (AS03) demonstrated poor health conditions with no foliage and fungi growing.

Photo B.1.1 : General view of the transplanted individual AS-03.

- The watering frequency for the two saplings of Incense Tree should be maintained at 2-3 times a week. Improve/place organic mulch around the two saplings of Incense Tree to retain soil moisture, protect damaged roots against extreme temperatures, and improve soil quality.
- The watering frequency of the cluster of Lamb of Tartary should be maintained at twice a week.
- The watering frequency for all clusters of Bottlebrush Orchid should remain the same. During watering activities, the surrounding dead branches and dry leaves should be removed to ensure no plants are damaged by them.

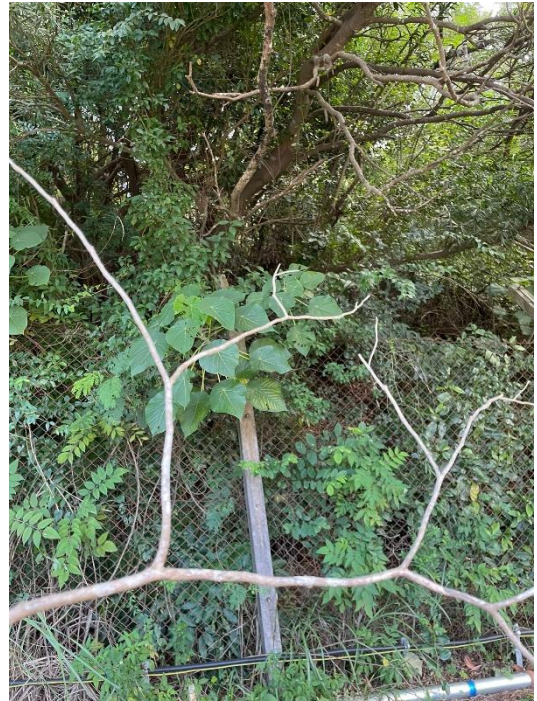
Photo B.1.2 : Branch condition of the transplanted individual AS-03.

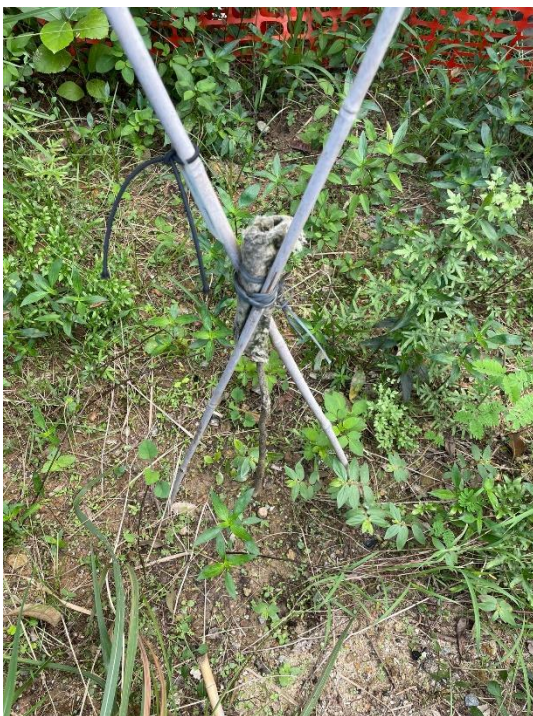
Photo B.1.3 : General view of the transplanted individual AS-02.

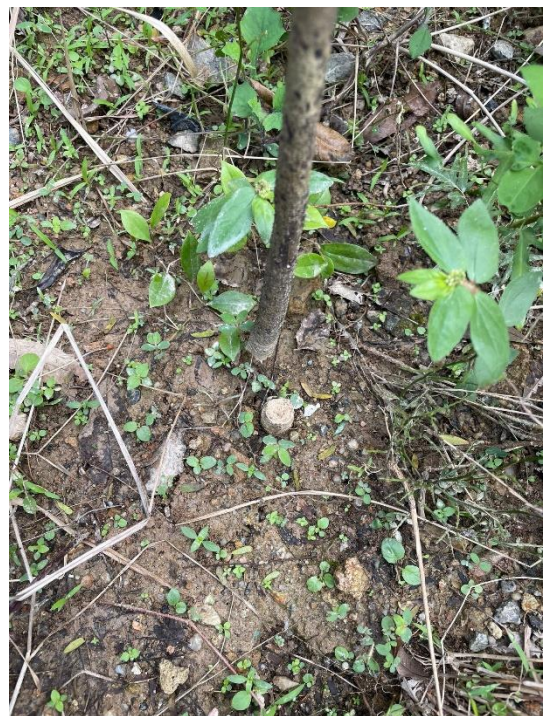
Photo B.1.4 : Broken stem of the transplanted individual AS-02.

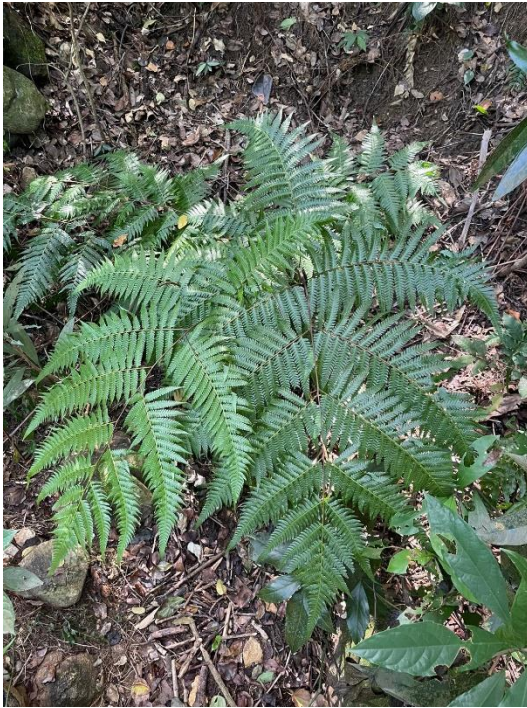
Photo B.2.1. : General view of the transplanted individual CB-01.

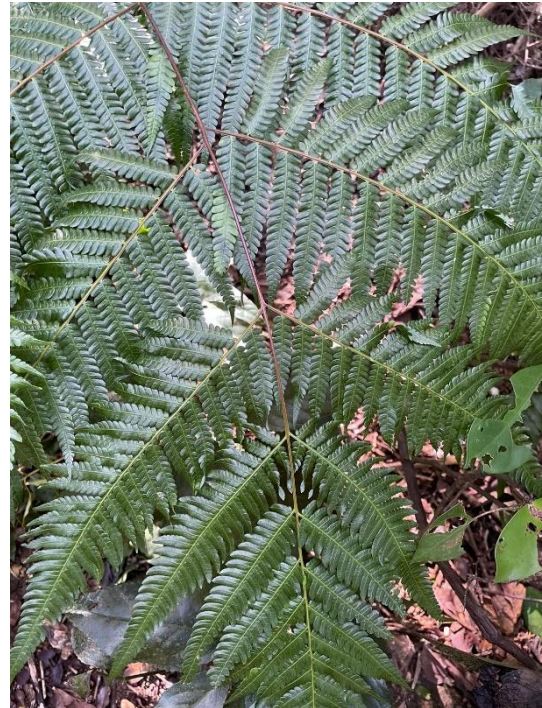
Photo B.2.2. : Leaf condition of the transplanted individual CB-01.

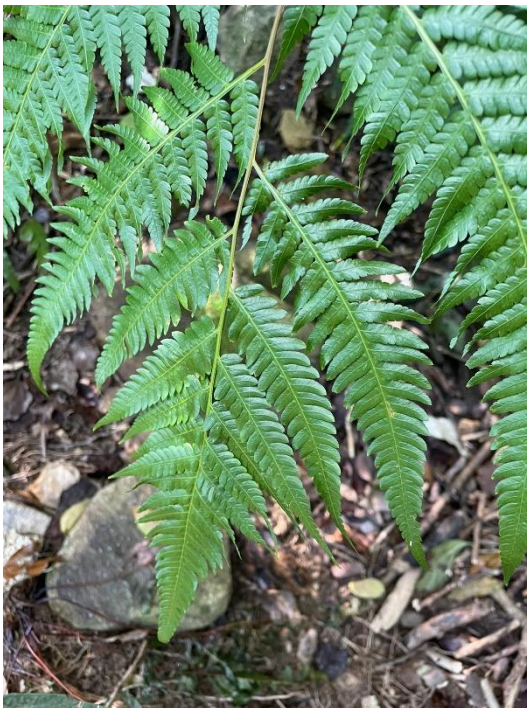
Photo B.2.3. : Leaf condition of the transplanted individual CB-01.

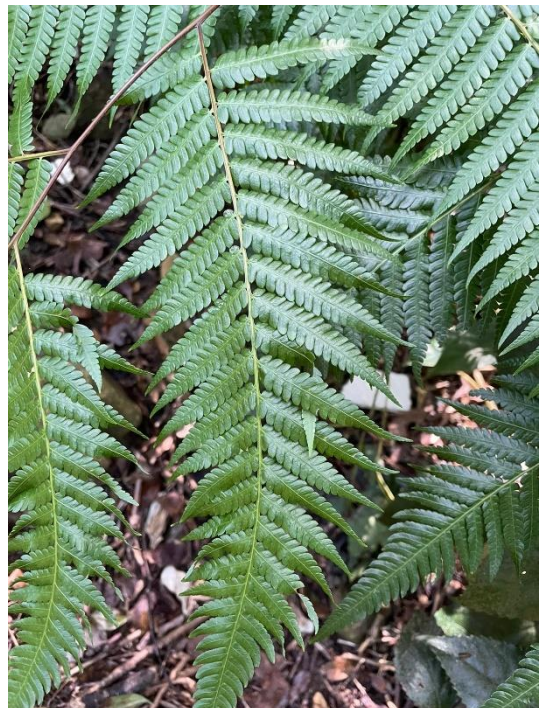
Photo B.2.4. : Leaf condition of the transplanted individual CB-01.

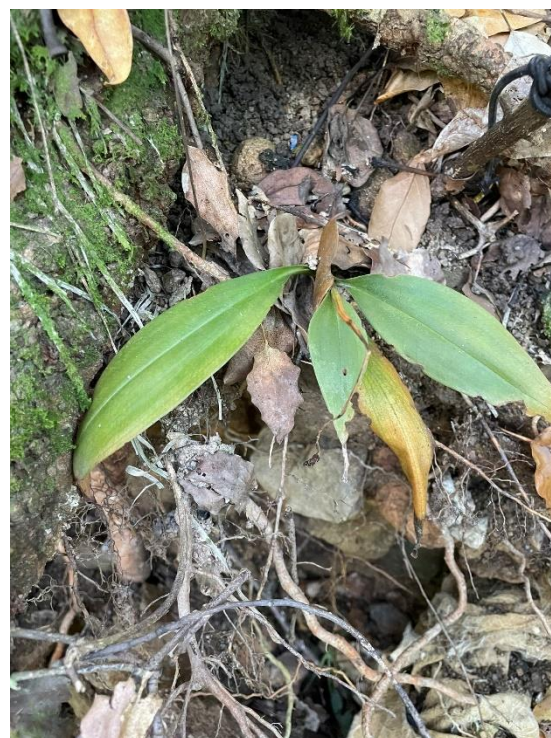
Photo B.3.6: Individual GP-16.

"	B	GP16	"			14			fair				chlorotic leaves
"	B	GP17	"			8			fair				holes on leaves
"	B	GP18	"			—			—				missing
"	B	GP19	"			—			—				missing
